Condition & Valuation Survey

Report No. IME/Job/18/04892

Date: April 24th, 2018

Acting at the request of Mr. Diego Maio, the attending surveyor did attend onboard the 1990 Moody 425 "Mischief", on June 07th, 2017 at 10:00 am where an "out of water survey" was conducted, at Linton Marina, Cristobal, Panama Republic of Panama.

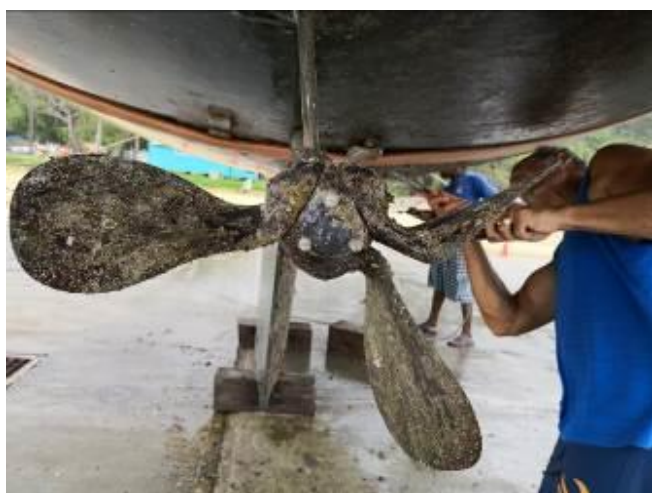
Prop.

- PROPELLER:
The bronze Burton folding propeller, it has three (3) blades for a variable pitch propeller. Good condition.
- PROPELLER SHAFT:
Prop shaft dimeters are 1 1/4 inch. Material: Stainless steel composite.
- PROPELLER SHAFT LOGS TUBES:
External visual examination proves to be in good condition.
- SHAFT BEARING (CUTLASS BEARING):
2 Cutlass bearing showed no signs of sloppiness or end play. Good visual condition.
- RUDDER MOUNTING:
Skeg hung mounted with stainless steel shaft. Well mounted and tightened.
- STRAINERS / SCOOPS / SCREENS:
All water pickup strainers are external bronze alloy slotted type. In good condition and well mounted
- GROUNDING PLATES:
One sighted in good condition.
- ZINCS:
All new and in good condition.

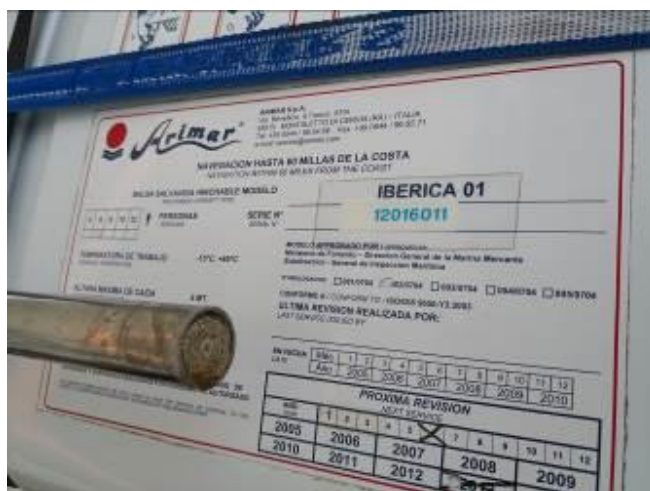
Life raft.

- LIFE RAFT:
6-person life raft well mounted and secure on bow of vessel. Overdue.
- SMOKE / CO DETECTORS:
Not fitted.
- FIRE ALARMS:
Not fitted.
- FITTED FIRE EXTINGUISHING SYSTEM:
Yes, MA20350227-BL in engine room with automatic and manual activation.
- BILGE PUMPS
LIST: The vessel is equipped with three bilge pumps; one (1) electric Rule 3000 pump, two (2) Whale Manual. All operable and secure.
- DINGHY
One (1) AB Ventus 9VL with One (1) Honda BF-230 2.3 HP outboard, One (1) Yamaha Enduro E15DMH 15HP outboard.

- Vessel it is not fitted with CO and Smoke detectors, we recommend being fit some of these devices.
- Epirb to be fitted.
- Distress signals to be fitted onboard.
- Extra anchor to be fitted on board.
- Life raft need to be serviced.

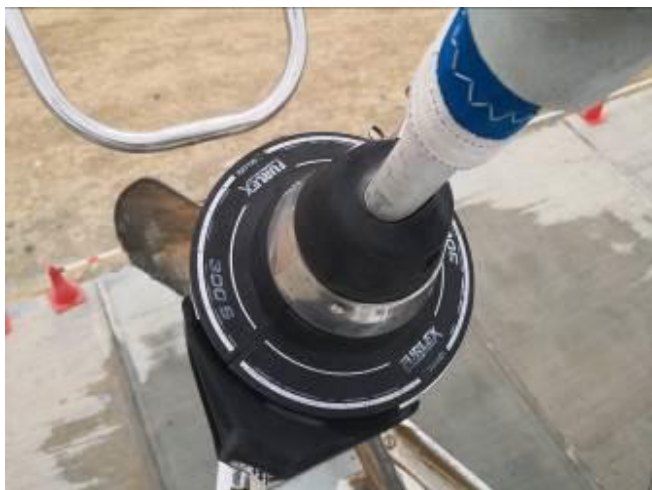
Roller Furling

- REEFING SYSTEM:
Good condition.
- HALYARDS:
Halyards were braided color coded.
- ROLLER FURLING GEAR:
Furlex 300S furling gear, appeared serviceable.
- CAM CLEATS:
Locking cleats well labeled and operable.
- SWIVEL BLOCKS:
Appeared serviceable where sighted.
- SNAP SHACKLES:
Serviceable.

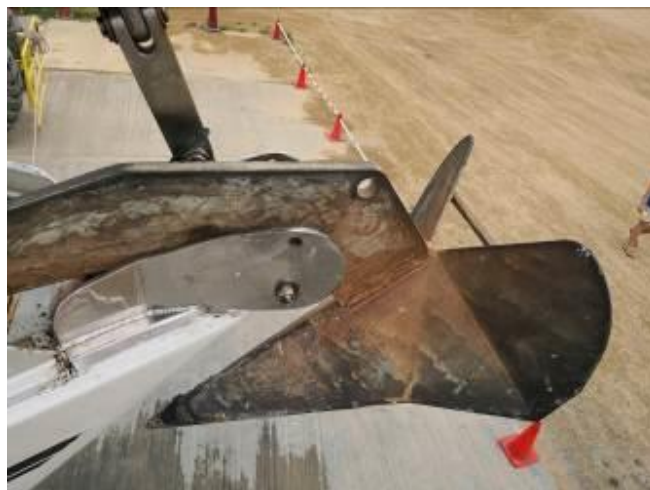
Anchor.

One of the bow anchors is a 110 lb Bruce with 350' 3/8" chain (2016). The other anchor appears to be a 66 Lb bruce attached to a 30' of chain and 300' of nylon rode.

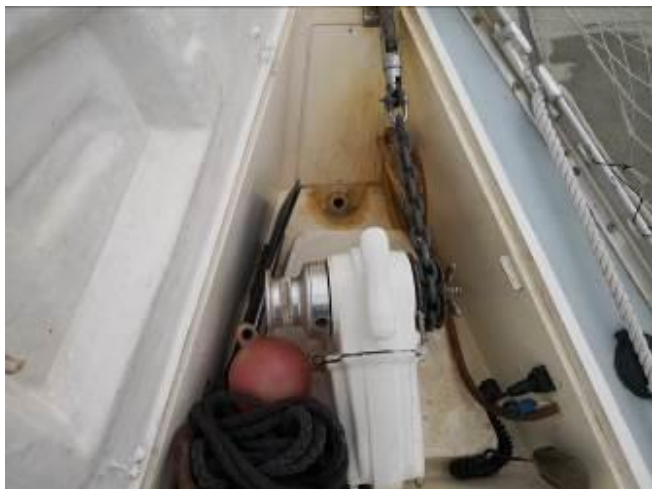
Lofrans Windlass.

Lofrans Tigress 1200W 12V electric windlass. Windlass has and foot switches

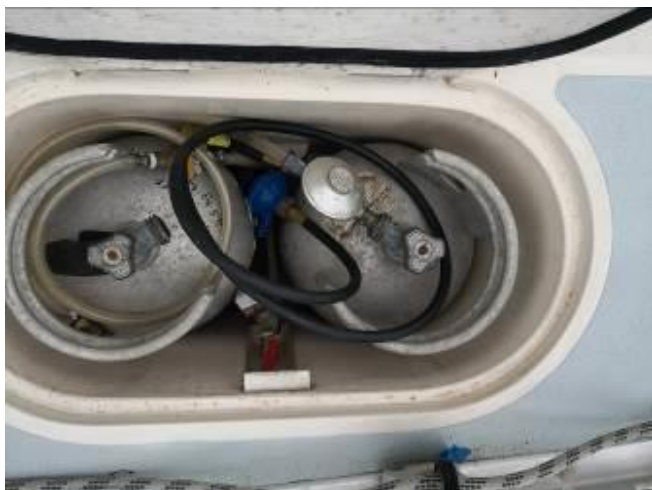
LPG locker.

- **LPG**
Vessel has a propane locker with two tanks locate port aft. It is gasketed and vented to the outside. A leak down test was performed to satisfactory results. Galley has remote on/off switch for propane. Gimble stove is well mounted and no signs of abrasion or cracking of propane hoses was evident during visual inspection.

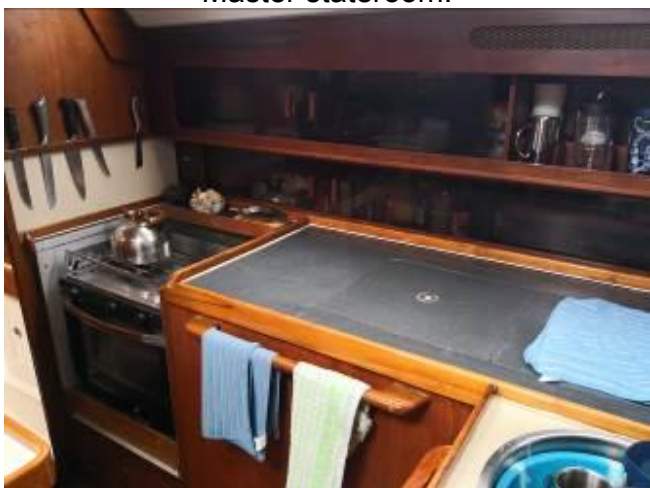
Galley.

Galley The galley is located in the port side aft of the main cabin. The galley is fitted with a two (2) burner stainless steel gimbaled ENO propane gas stove with oven. There is adequate storage space for food and utensils. The galley has two (2) Rich Beers refrigerator/freezer systems, single stainless-steel sink.

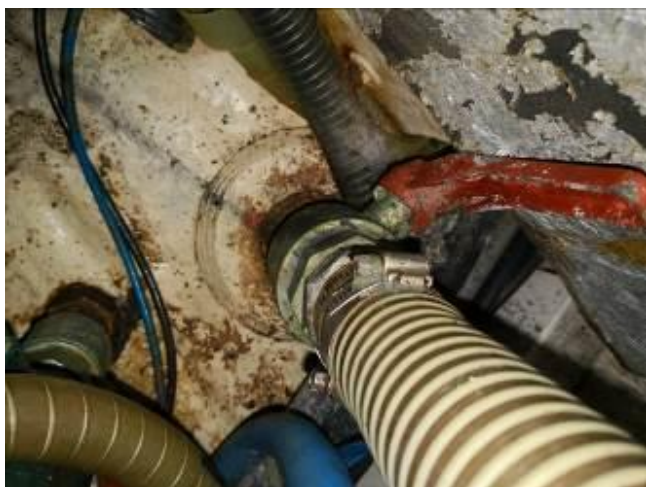
Engine seacock.

Raw water seacock is a ball valve type, well mounted to through hull and was operable. Strainer was clean, in good condition and well mounted.

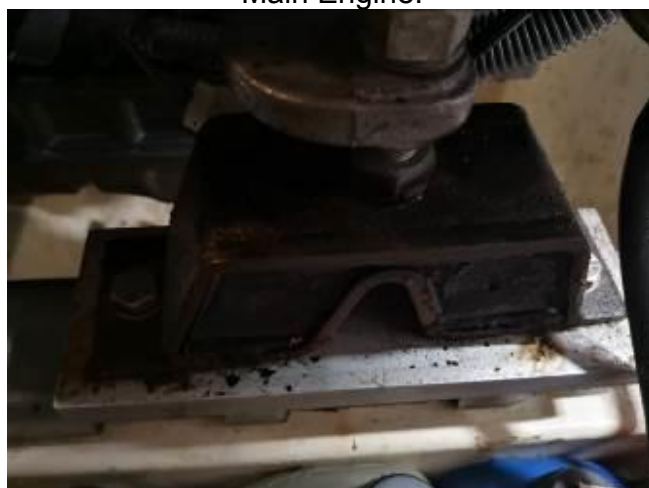
Main engine mounting.

- **EMERGENCY SHUT DOWN:**
Key switch and fuel shut offs.
- **ENGINE MOUNTS AND BED:**
The main engine bed has large longitudinal stringers. In conjunction, adjustable motor mounts are bolted to the stringers and are used to adjust the prop shaft alignment as well as secure the engines to the hull stringer structure.
- **BILGE BLOWERS:**
Operable at time of survey.
- **EXHAUST SYSTEM:**
All components of the exhaust system inspected by the surveyor at time of survey including manifolds, rubber hoses, exhaust dampers, mufflers, elbows, supports and FRP tubes were found to be in good condition and well mounted without signs of rust, water leakage or exhaust gas leakage. Serviceable.
- **PROP SHAFTS:**
Stainless steel composite 1 1/4" diameter.

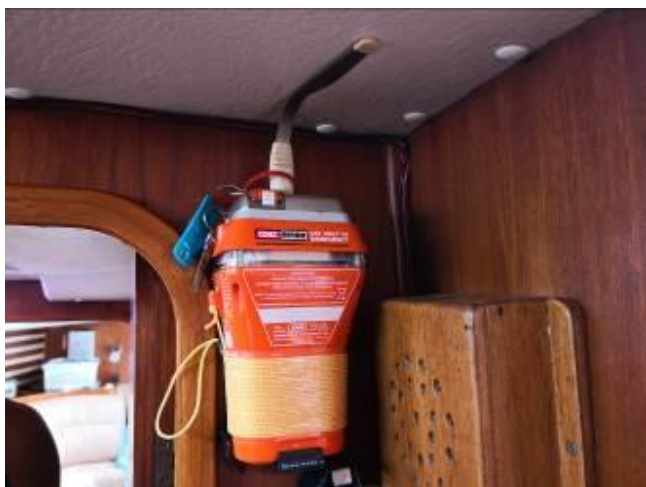
EPIRB.

- NUMBER AND TYPE OF PFD'S:
4 Adults. U.S.C.G. approved.
- EPIRB:
Expired.
- NUMBER OF THROWABLE PFD'S:
Two (2) Type IV-U.S.C.G. approved throwable device.
- FIRE EXTINGUISHER:
Two (2) 1 lb Kidde ABC / One (1) Flame Fighter 2 lb ABC, additional fire blanked.
- VISUAL DISTRESS SIGNALS:
None
- SOUND DEVICES:
Horn on board vessel. Operable.
- NAVIGATION LIGHTS:
All navigation lights were operable at time of survey.

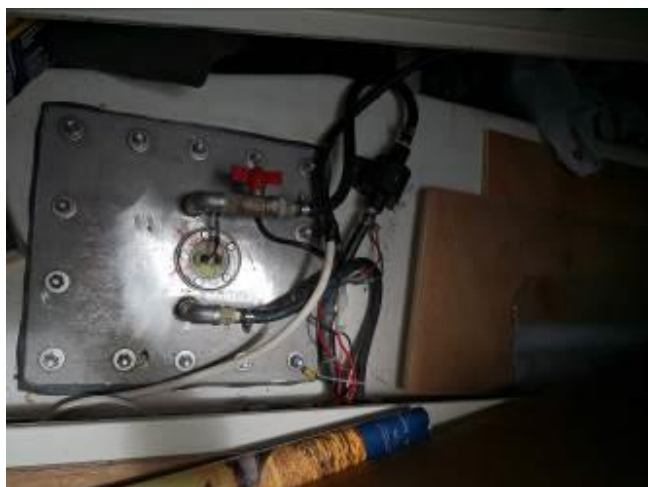
Fuel tank.

- FUEL TYPE:
Diesel. Tank was visually inspected only. It appears to be in serviceable condition with no signs of leaks and no fuel odors.
- TANK MATERIAL:
Black Iron.
- NUMBER OF TANKS:
1
- TANKS CAPACITY:
150 gallons
- LOCATION:
Under bed in master stateroom.

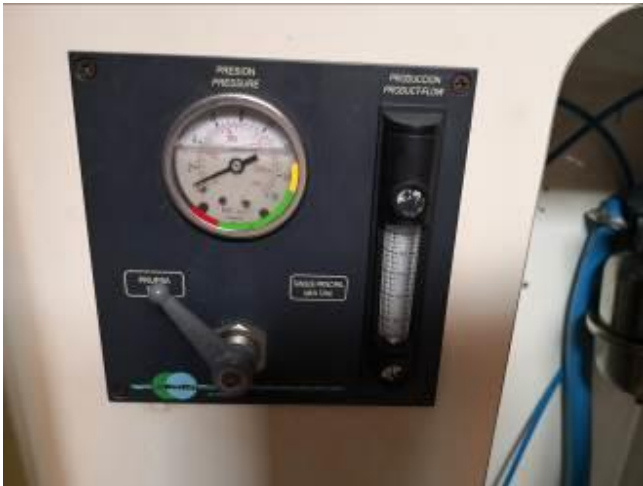
Water maker.

- DESCRIPTION:
ECO Systems water maker system noted on board. Not tested for operation at time of survey, mounted modules in good visual condition.
