Failed Blister Repairs

A Case History and Solutions

Blister Repairs Part II

The Alchemist Still Hasn't Found the Philosopher's Stone

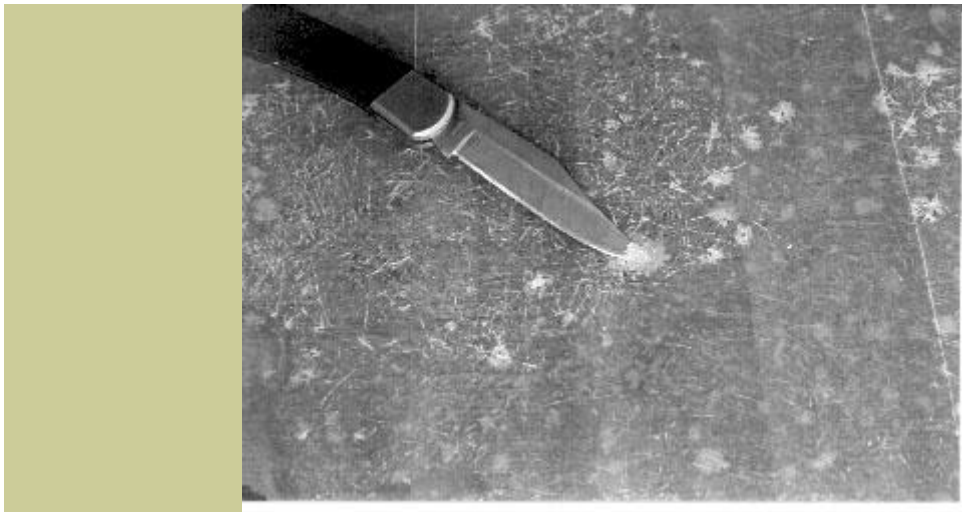
After removal of the newly applied barrier coatings, this is what Mr. Williams hull looked like. Knife blade is inserted into the void spot caused by the old blister. Most, if not all, of the original blister voids remained. At right, the new resin can be seen to have been applied directly over the old blisters.

- As shown in nearby photos most, if not all, of the old blister cavities were still present. As far as we could determine, no effort was made to grind away the cavities or void areas and fill them.

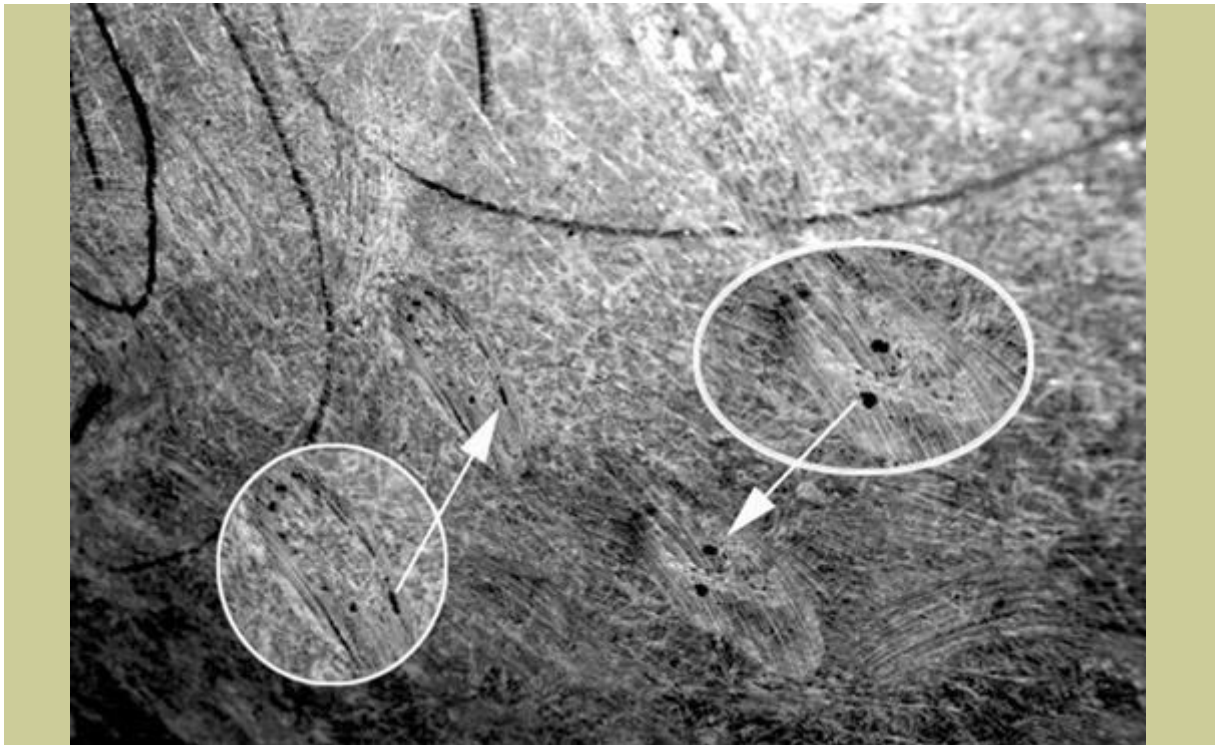
- Scattered and random areas of the original skin out mat, as part of the original lay up, had significant areas of unsaturated fibers and minute voids, i.e. air bubbles in the original lay up.

Although these blisters were ground away, the void spots or air bubbles within the skin out mat that initiated the blisters are clearly evident in this photo. The circled insets are enlarged for clarity. The polyester plastic here is not hydrolyzed (dissolved) as some researchers claim is the cause of the problem. The plastic is hard and unaffected. If these voids are not removed, then the potential for reformation remains. Also note how dry some of the fibers are.

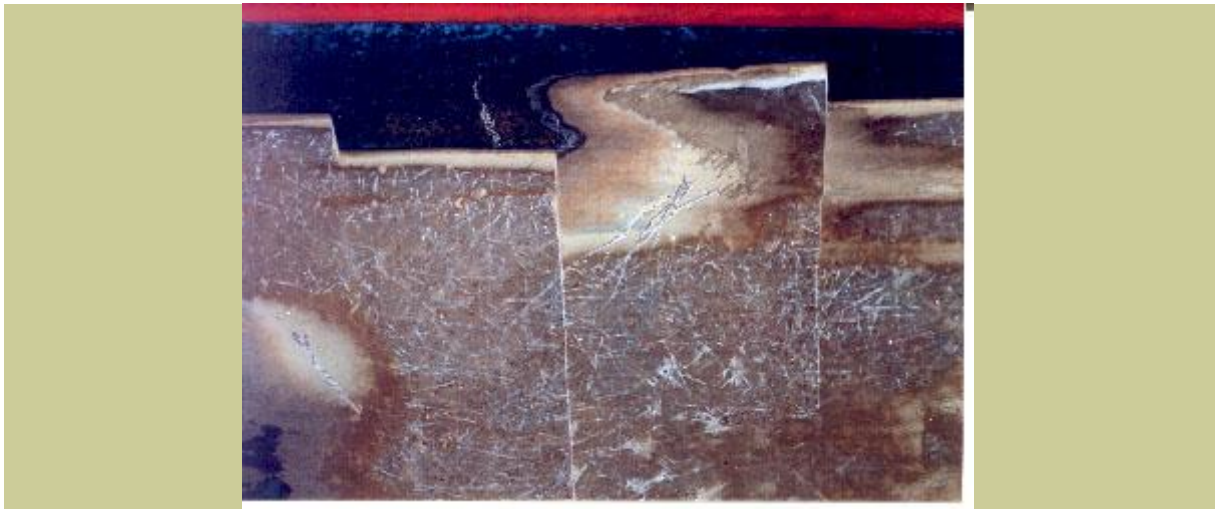
- Some areas which had been faired with an unknown filler, but looks like two-part epoxy, were very soft and pliable, giving the appearance that it had not been mixed in proper ratios and did not cure properly. Since some of this material was hard, and some soft, we do not consider it likely that the material softened of its own accord.

Fairing material that either turned soft or was not properly mixed and catalyzed. Scrape marks were made with the end of a ball point pen to indicate how soft it is, a perfect environment for blister formation. This is the point where the bottom was faired into the old gelcoat at the boot stripe. Note blister voids at lower center.

It also appears that a two-part epoxy filler was used in the fairing process that amounted to no more than 25% of the bottom area. This included spot filling depressions of what might have been larger blisters, as well as fairing around through hull fittings, fairing the waterline into the removed bottom gelcoat, as well as just general fairing. The fairing process was poorly accomplished, resulting in a "lumpy" appearance to the finished job. Most significantly, as we have found in a large number of other failed blister jobs, the fairing material, whatever it is, was found to be soft and pliable. Whether this resulted from improper mixing and incomplete curing, or if the material softened from water exposure or resultant chemical reactions, was not precisely determined. However, it would certainly be difficult to sand a filler that was not completely cured, and the fact of the lumpy appearance of the bottom suggests this possibility. On the other hand, our finding of so many other fillers that turn soft also suggests the likelihood of problems of (1) incompatibility of materials being combined, or (2) that these materials are severely affected by contact with sea water. All we can say for certain is that it is a two-part mix and that the material in many areas, although not all, was very soft.

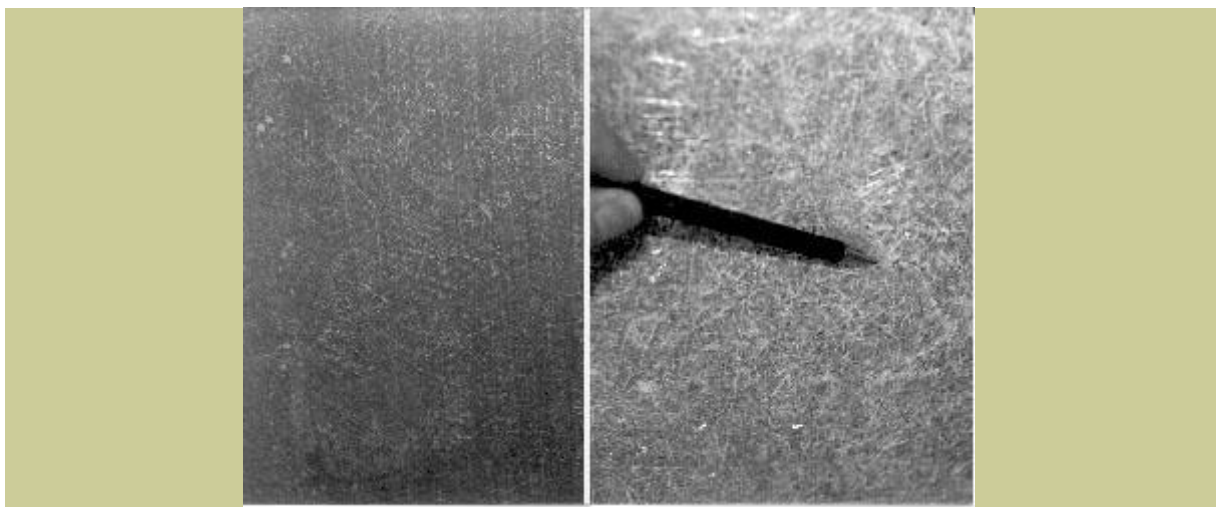
Comparison view of fully saturated skin out mat at left, poorly saturated mat at right also showing numerous void spots or air

bubbles. Notice that no blisters appear in the fully saturated laminate. These two areas are the same boat hull. Doesn't this tell the real story of how and why blistering occurs? If the laminate is fully saturated, blisters CAN'T develop.

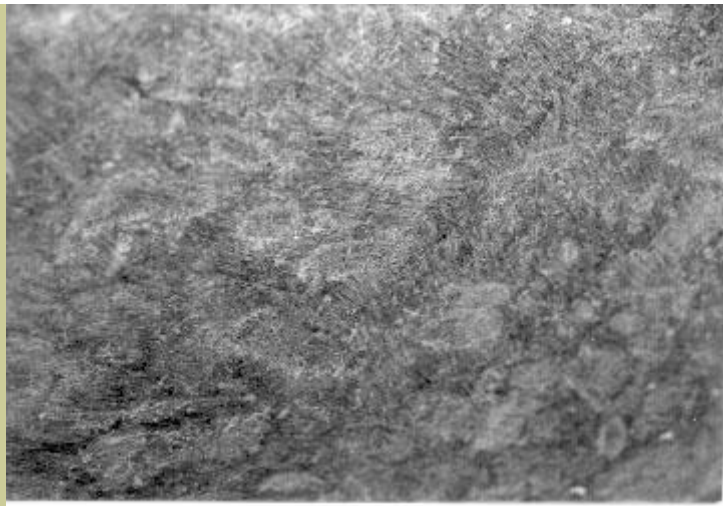
This photo, not this essay's subject vessel, shows a boat bottom with at least two dozen grind spots in little more than one square foot area. Despite all the grinding, hundreds of voids and areas of unsaturated fibers remain. When the condition of the skin out mat is this bad, it cannot be successfully repaired. It must be removed completely.

Unfortunately for the owner, the yard simply filled the holes and recoated it, with a high probability that the repair will fail.

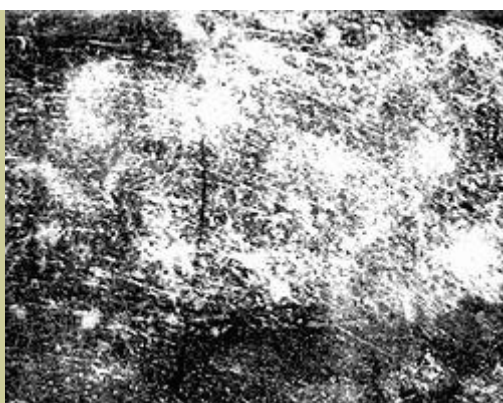
Here is a particularly good shot of unsaturated fibers in a skin out mat. These really stand out because the layup resin in this hull is tinted dark blue. In most cases, the poorly saturated fibers do not stand out this well. In this case, as in so many others, the repairer simply applied a new barrier coat on top of this mess and the blisters reappeared with six months.

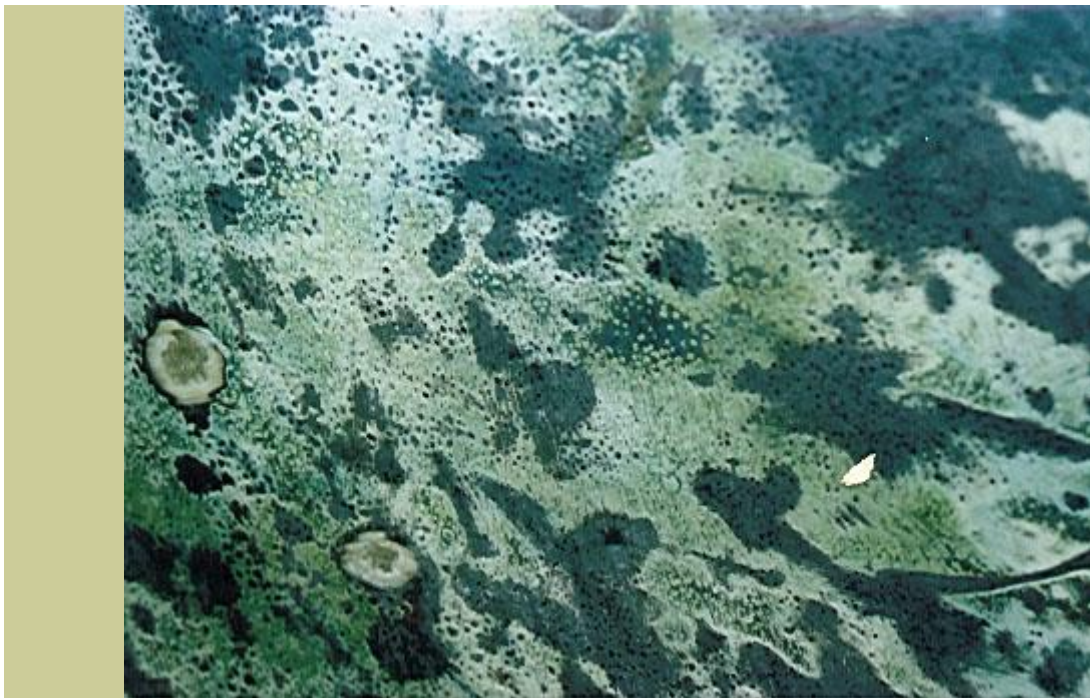
Another failed repair job. This one looks like the so-called "hot coating" where the bottom paint is applied over a wet barrier coat. At left are two larger blisters to which a grinder was applied. The skin out mat layer is plainly evident, is around 3/16" thick and is completely opaque, in addition to having a faulty bonding surface to the structural layers. Under the white layer, which you might think to be gel coat, is a black layer. We can't even imagine what that might be. What has been done to the bottom of this boat over the years (it is 15 years old) is beyond even guessing, but the one thing that is certain is that it there is no hope of successfully repairing it, even though the owner is

going to try again. Applying a new coating over this mess is like painting over dirt.

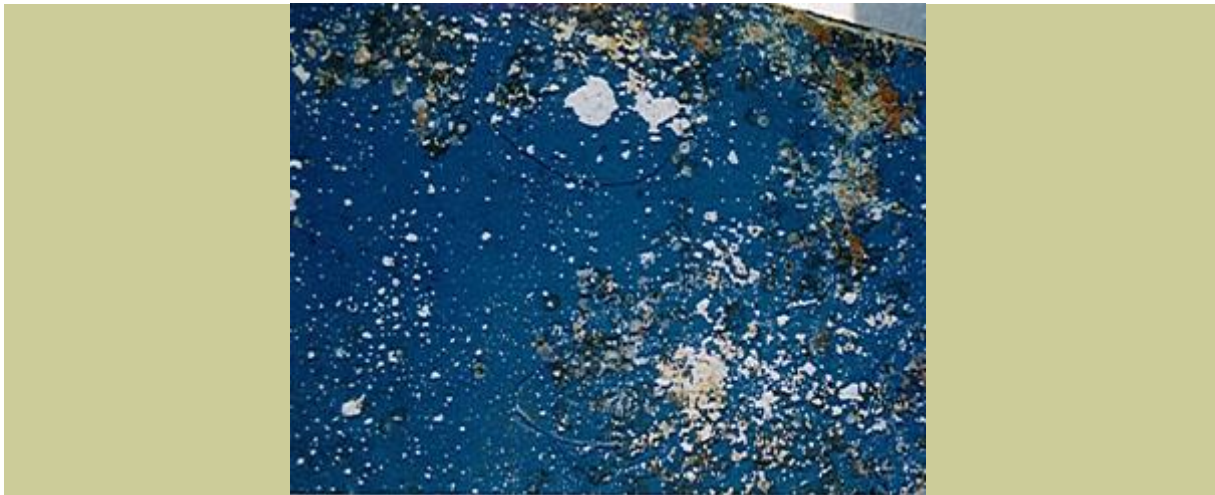
Top: What you see here may look like gel coat blisters but actually the white spots are a chemical reaction between a variety of gunk that was smeared on the hull. There was almost no gel coat left.

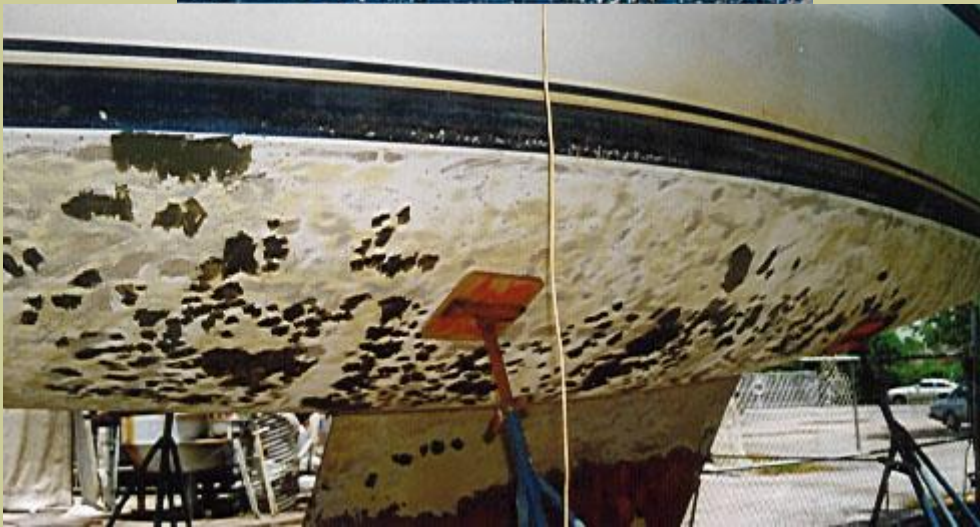
Below: This is what it looked like after some kind of machine was used on the bottom. Here we can count four different kinds of filler, in addition to the black stuff that is now being applied on top of all the others, another patch up job. After he's done, he is going to seal all this mess over with a barrier coat. This owner's efforts are a complete waste of time and money.

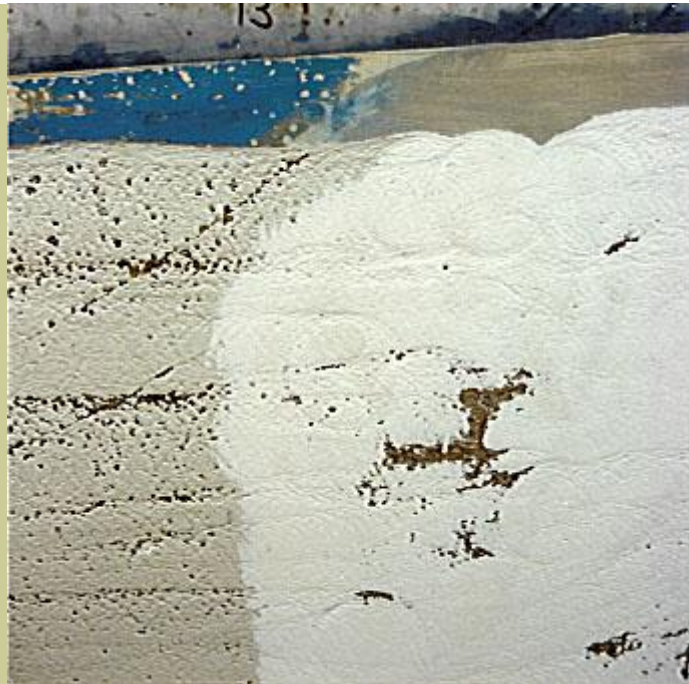
The effects of rotary pressure stripping. This process does not remove the gel coat but merely erodes it, leaving it in worse condition than ever. A barrier coating applied to a surface like this is an exercise in futility and a waste of money. This is not the first time around for this boat: notice the prior repaired area at right. This is the third time around for this boat.

- Virtually the same result occurs when these rotary water pressure strippers are used. The end result is as bad as sandblasting. It pocks the gel coat and shreds the exposed fiber bundles, opening up more channels for water ingress.

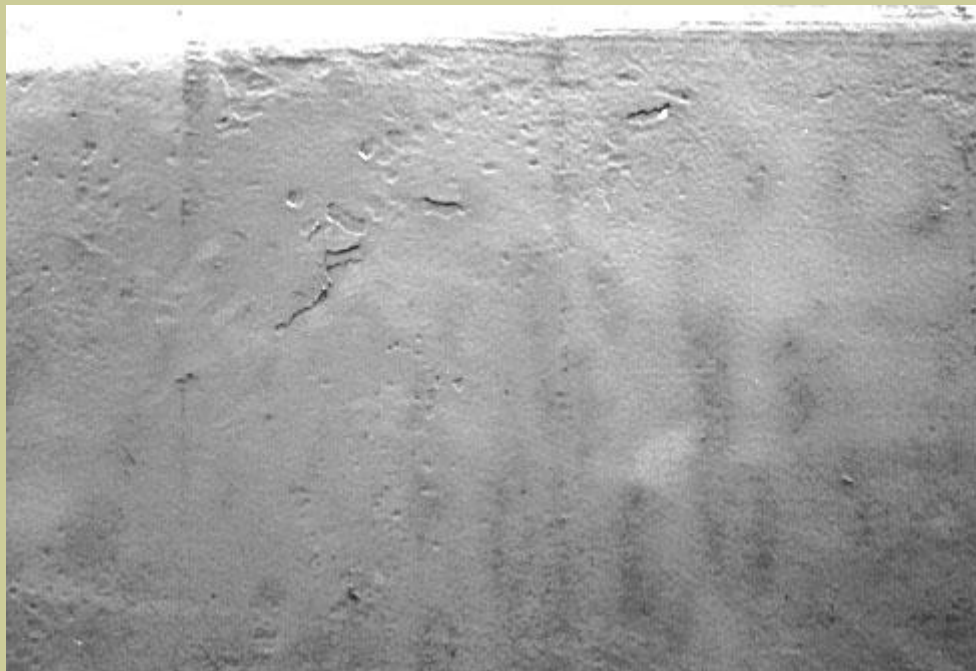
This bottom was barrier coated after sand blasting. The craters in the gel coat still remain and the surface is now more porous than ever. The blisters returned with a vengeance. They didn't even bother to fair out the craters. Unfortunately, this kind of repair work has become common.

- Under no circumstances should you ever sand blast or sand sweep a bottom. Sandblasting shatters the plastic and exposes the fibers far more than they already are. In addition, it craters the gel coat with millions of craters that only worsens the problem when it is sand swept.

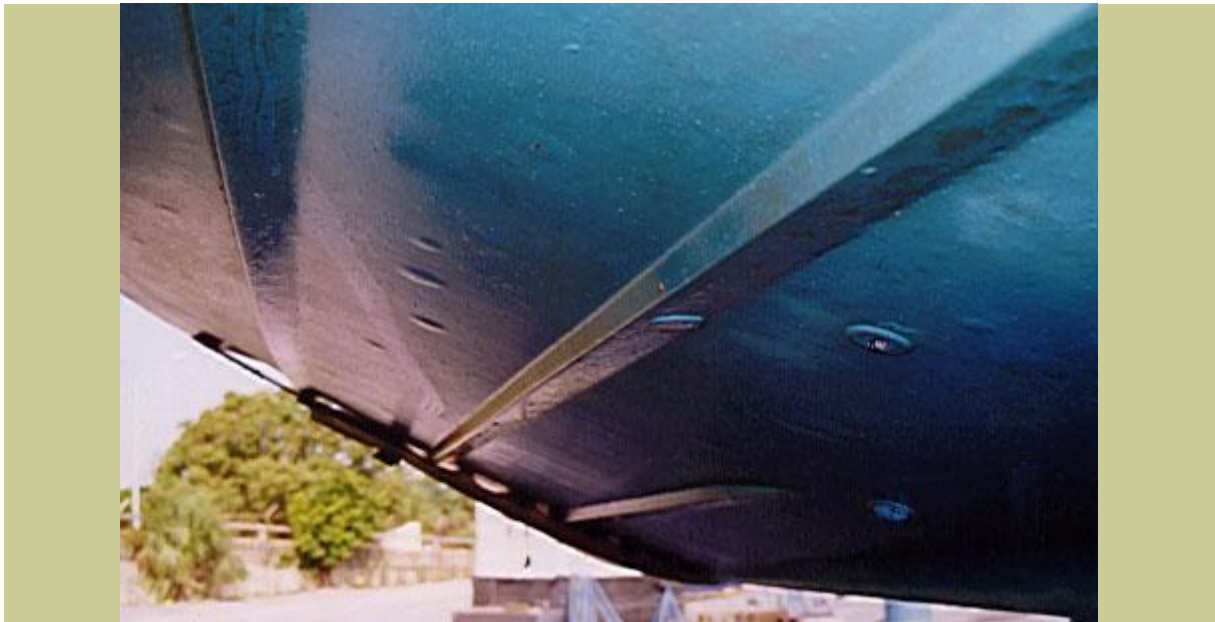
Here's a 22 year old Bertram with about 100 blisters on the bottom. It has never had any kind of repairs. Is it worth tearing up the bottom and risking making the situation worse? Or would the owner just be better off leaving it alone? We'd opt for the later.

Boats with a relatively small number of larger blisters (1" for example) are amenable to spot repairs, which are often successful. If the bottom of your boat has, say, 100 blisters on the bottom, we would recommend spot repairs over stripping and recoating the bottom. We would not recommend barrier coating after spot repairs. Spot repairs are inexpensive, and if they do fail, at least you won't be out a lot of money.
