A Short Guide to Osmosis & its Treatment

Written by Nigel Clegg

Revised Edition

Includes Suggested Moisture Readings and Painting Specifications, and an introduction to the HotVac system

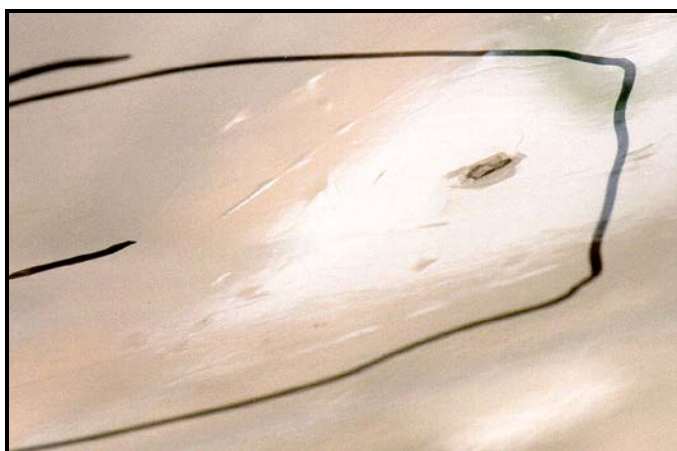
Fig 6: Fibre swelling in bare white gelcoat. Fibre swelling is not caused by osmosis, but by capillary action in fibre bundles behind the gelcoat.

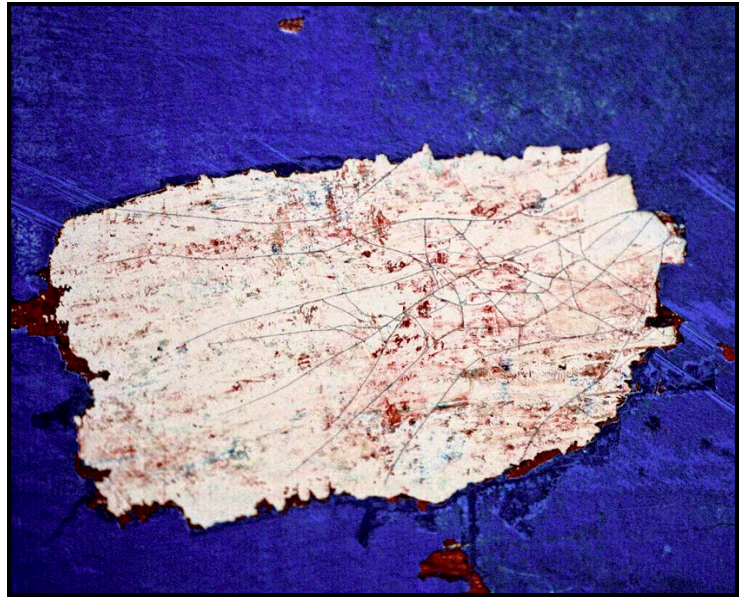
Fig 7: Antifouling coupon exposing gelcoat crazing.

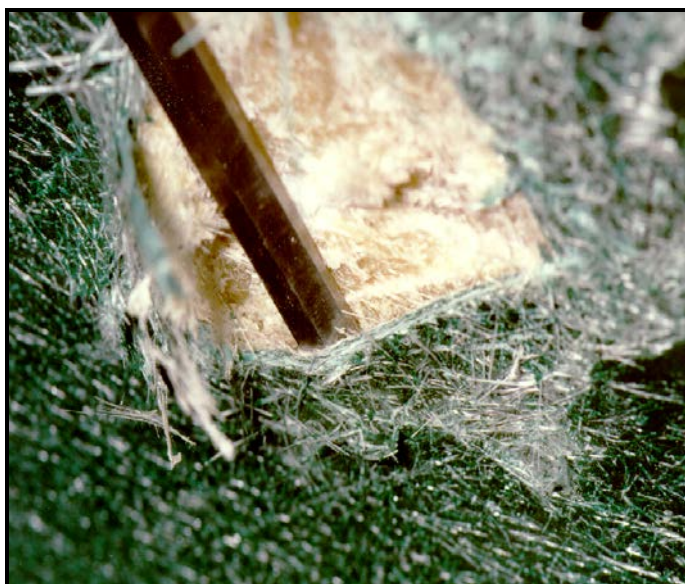
Fig 10. This poorly consolidated laminate had very little adhesion between layers of reinforcement, and was suffering from loss of mechanical strength.

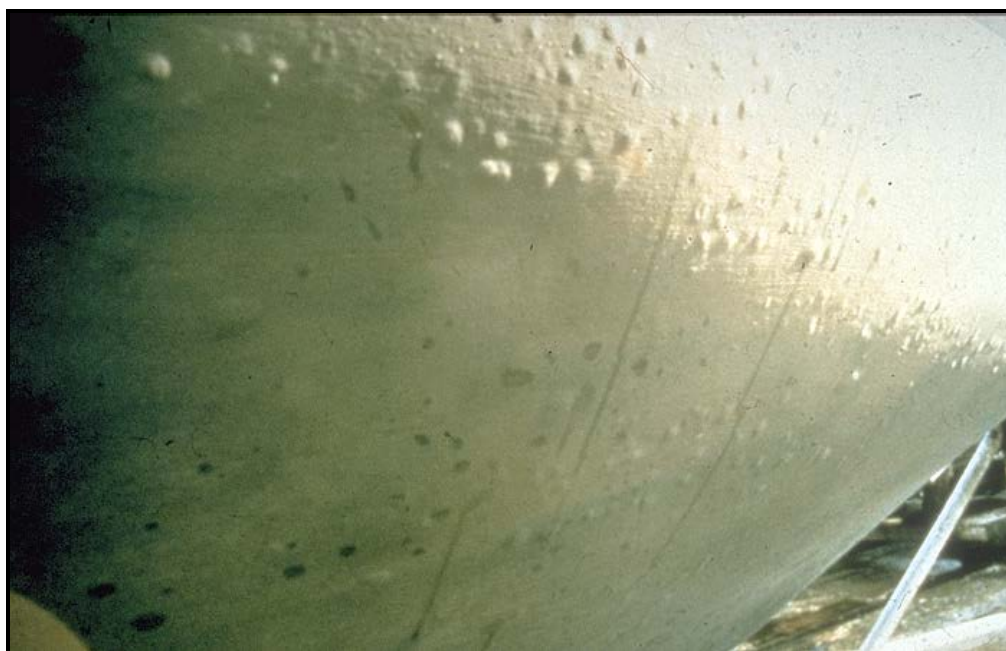
Fig 11. Blistering like this takes many years to develop, and will not be cured by any amount of heating or de-humidification. The HotVac system has proved very successful for treating ‘problem’ boats, but peeling, blasting and thorough fresh water washing remain an essential part of the process.

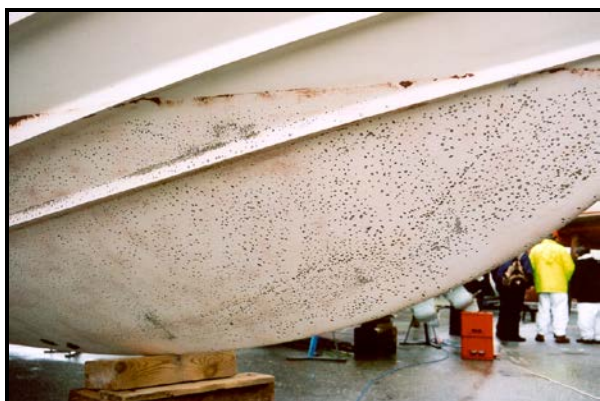
Fig 14. A poorly prepared laminate.

Note that little or no gelcoat has been removed from this hull, making removal of hygroscopic solutes next to impossible.

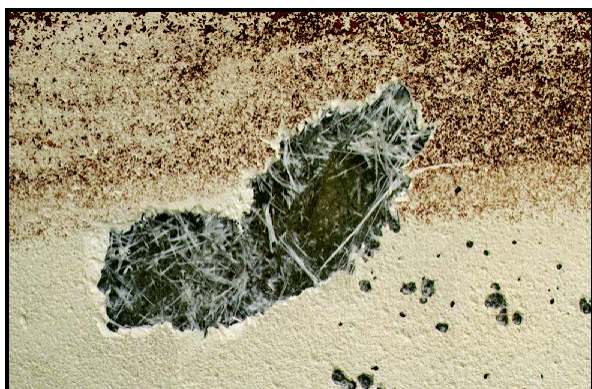
Fig 16. Unbound fibre behind a yacht's gelcoat.

Unbound fibre like this tends to harbour solutes, and will make successful treatment difficult.

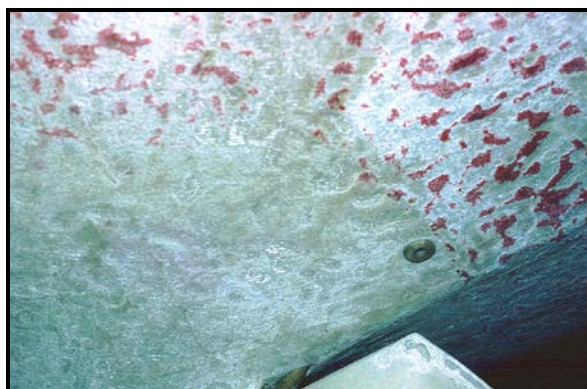
Fig 17. A well prepared laminate.

Note that nearly all gelcoat and unbound fibre has been removed from this hull.

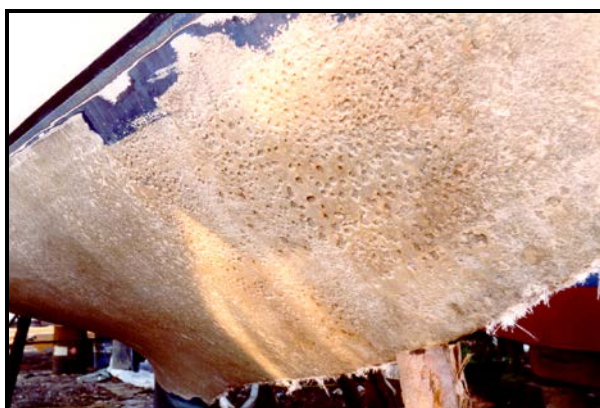
Fig 18 (left) and Fig 19 (right). These photographs show examples of good laminate preparation, with most or all of the gelcoat removed, and no loose or poorly consolidated reinforcement visible. Preparation to these standards will usually require extensive filling and fairing, but the treatment will be much more reliable as a result. Please note that the pock marks seen in **Fig 18** above were caused by large air inclusions (introduced at newbuild), and not by osmosis!

While it is true that many Osmotic hulls are found to have hundreds of 'voids' when their gelcoats are peeled off, (See **Fig 18** on page 14), these voids will almost certainly have originated as simple 'air inclusions' at new-build, which remained hidden inside the laminate until they were exposed during osmosis treatment. Similarly, laminates which are found to be severely lacking in resin, and are de-laminating were almost certainly laid up this way.

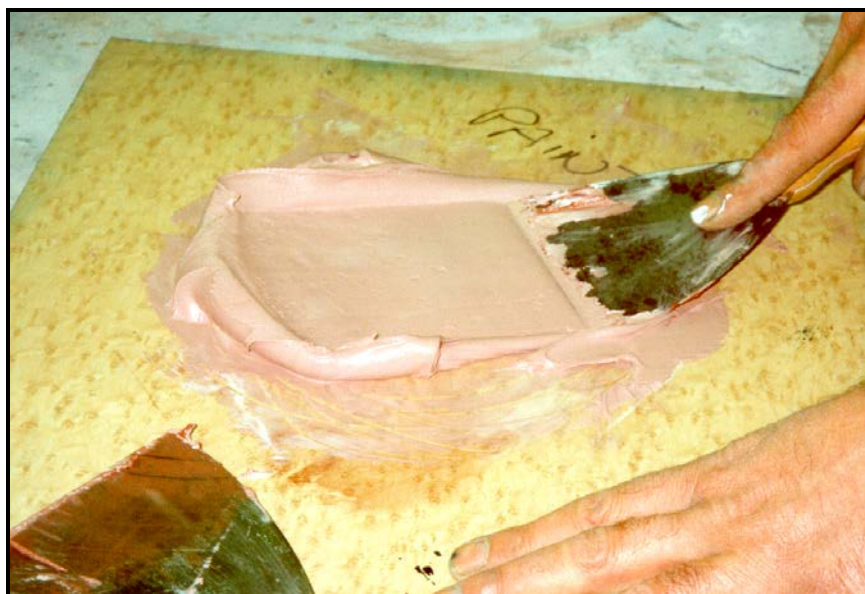
Fig 24. Epoxy fillers must be mixed thoroughly to ensure complete incorporation of the two components. Protective gloves should always be worn whenever mixing or applying epoxy materials!

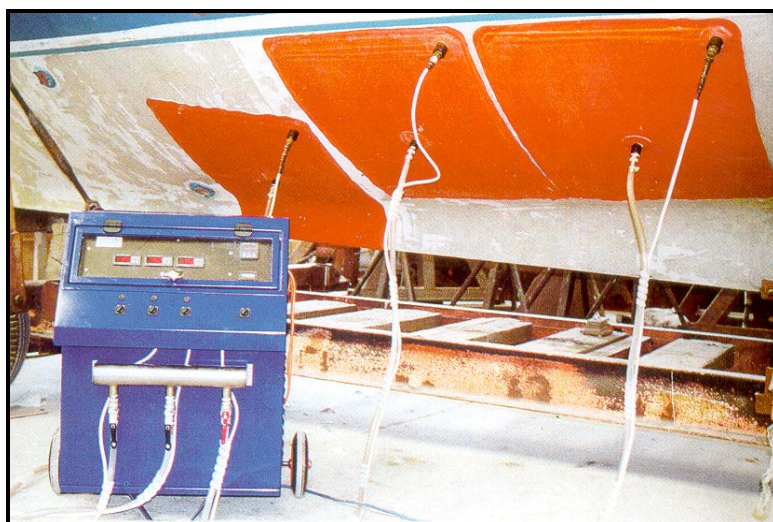
Fig 29. The Terry Davey “HotVac” system in use on a large GRP patrol boat at Fox’s of Ipswich.

Being inherently flexible, the heated silicone blankets conform intimately to the shape of the yacht's hull, and are simply applied after normal mechanical preparation as outlined in this paper. Specially shaped blankets and small blankets are available for confined spaces, bows and unusual hull configurations.

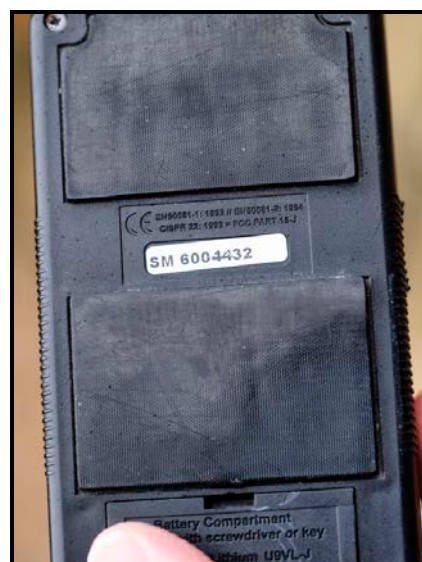
However, with constant use, the soft rubber electrodes on Tramex meters eventually lose their fine surface pattern, becoming worn and shiny like those in the picture below. This will noticeably reduce the instruments sensitivity to moisture. Similarly, the coaxial cables on older Sovereign meters can fail, whilst the scanning heads themselves will become worn. And of course meters can easily be damaged whilst in use, or even dropped into the water!

Worn electrodes like these will reduce sensitivity.
